TECHNICAL MEMORANDUM**City of Alexandria Storm Sewer Capacity Analysis****Task Order 2B – Cleaning & CCTV (King St, Beauregard St, and Walter Reed Dr)****PREPARED FOR:** CH2M HILL**PREPARED BY:** Baker**DATE:** April 2, 2012 (Revised Aug 7, 2012)**Field Work Summary (February 24, 2011)**

Storm Pipes Inspected by VPS

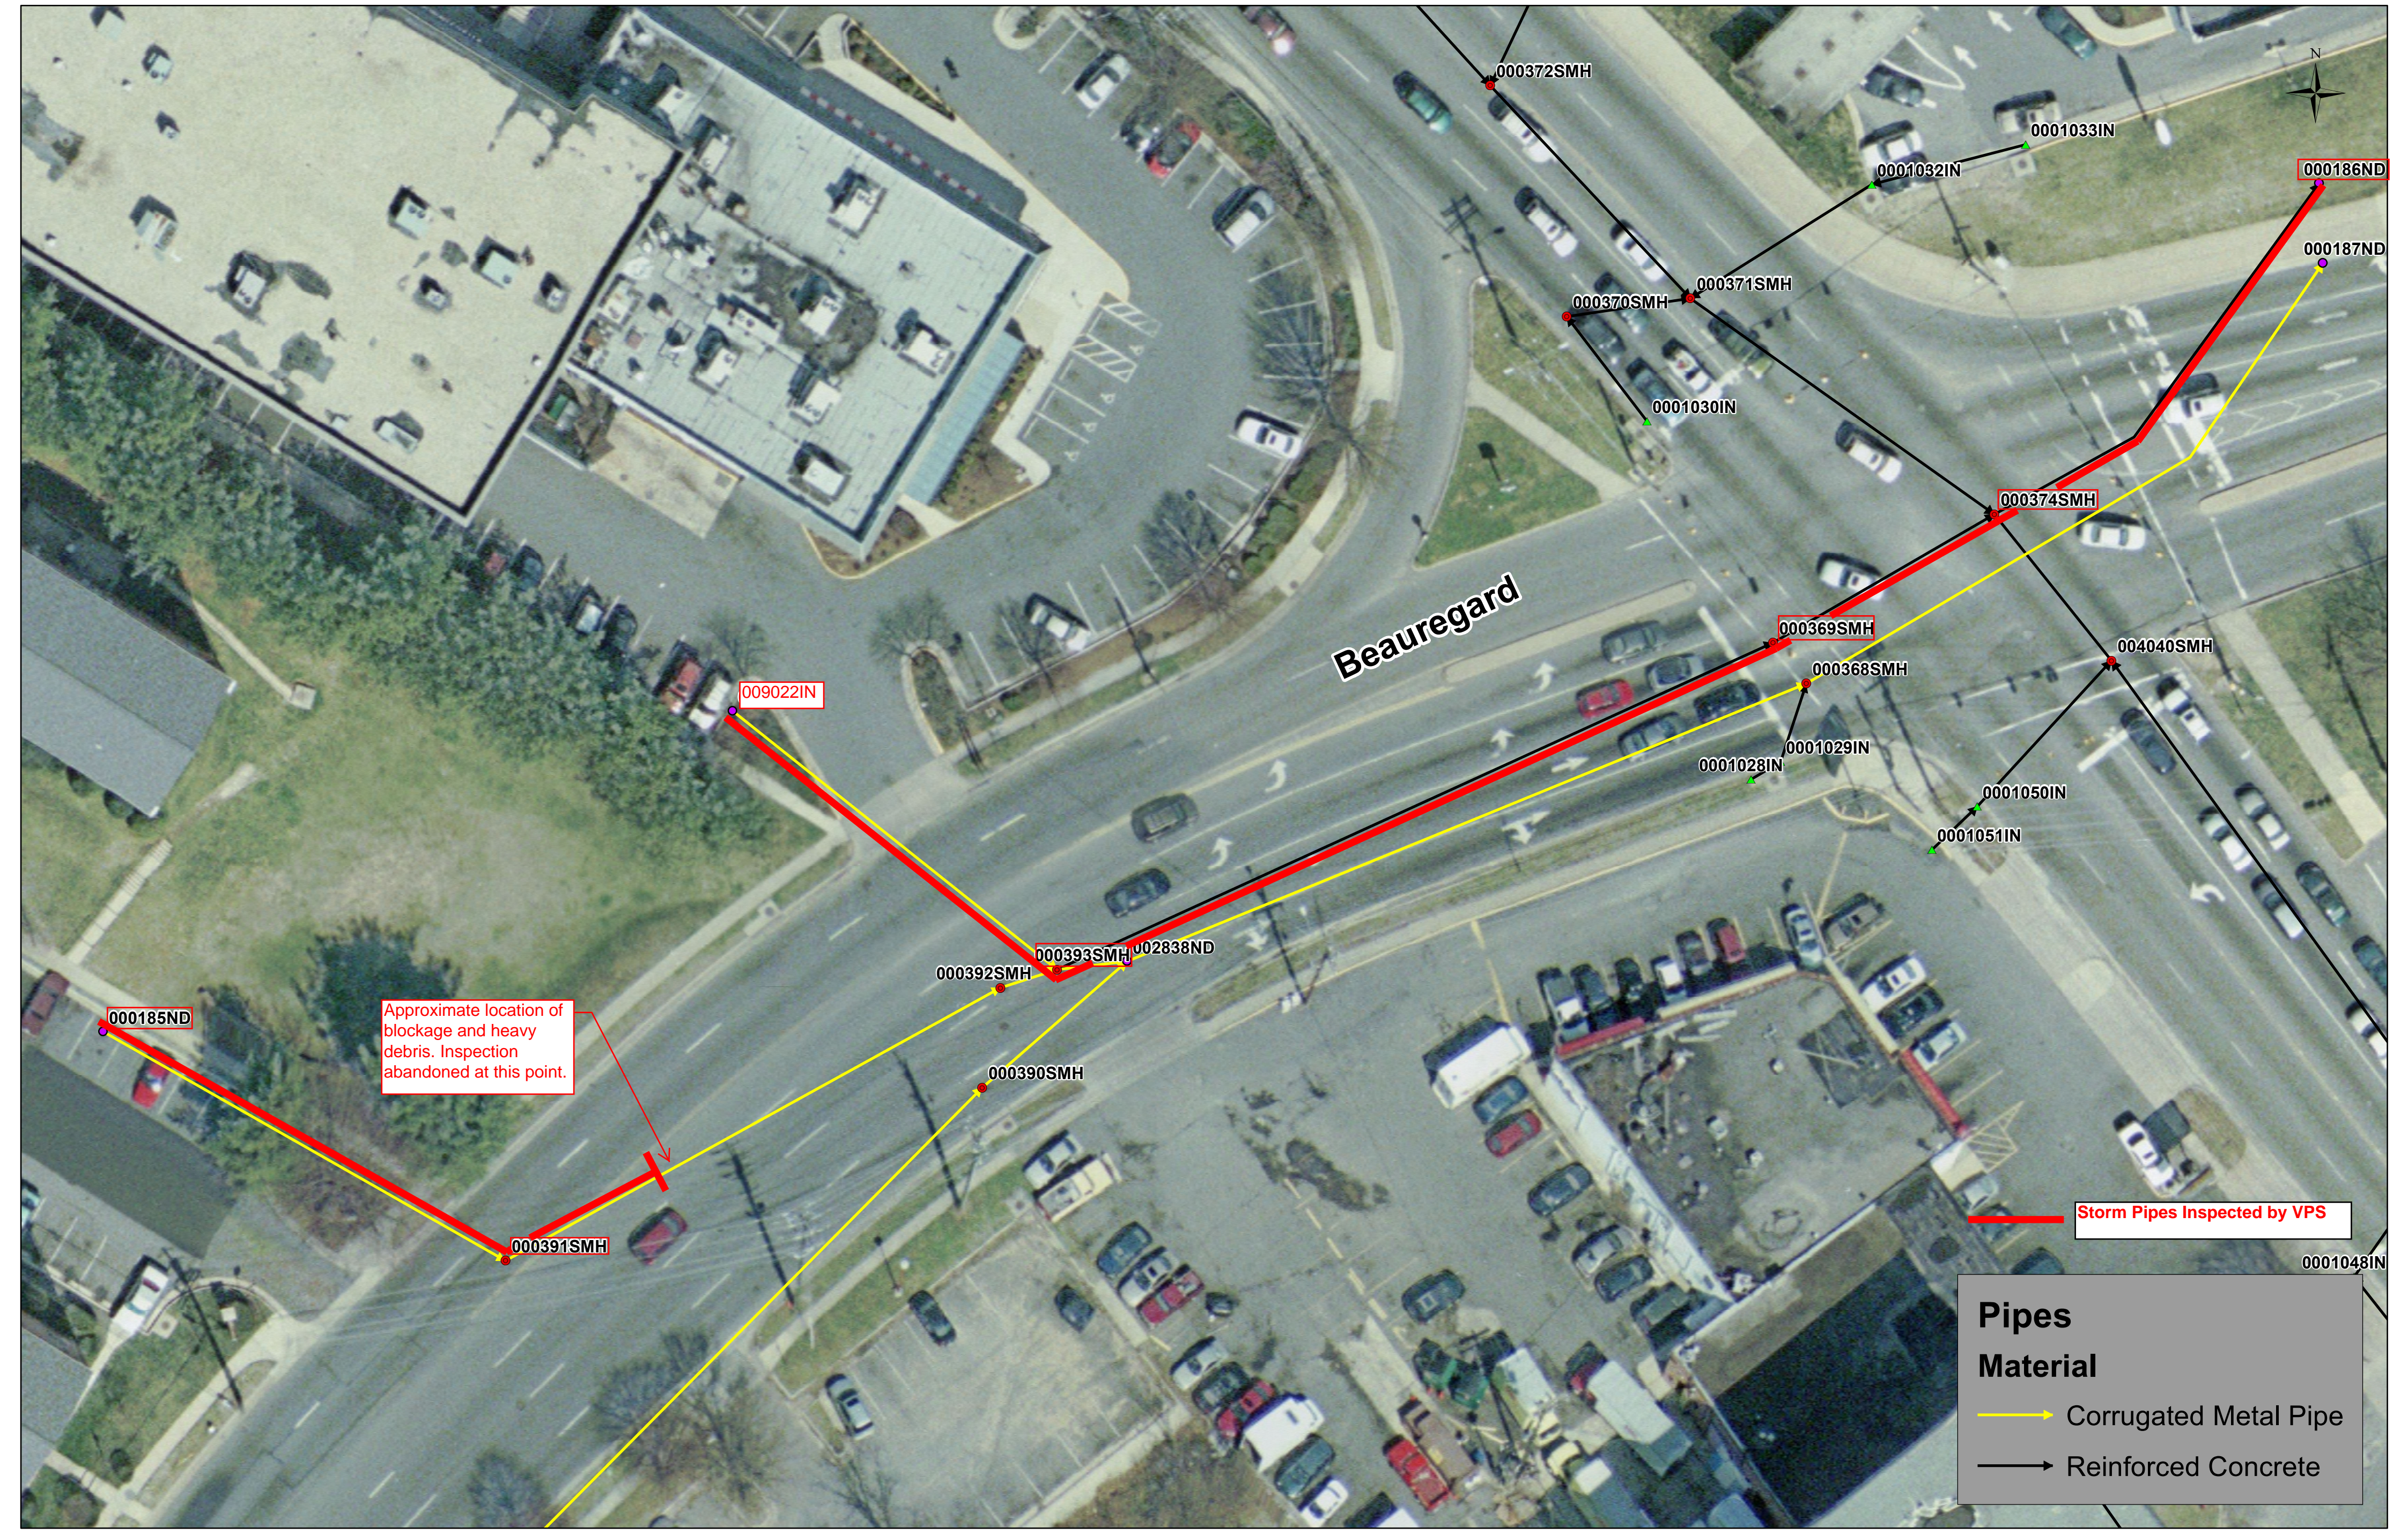
The inspection of the pipe connecting structures 000391SMH and 000393SMH was not completed beyond 34 feet downstream from 000391SMH due to the presence of heavy debris that could not be cleared using regular cleaning methods. The blockage consisted of bricks, concrete slabs, and other metal objects. Removal will require heavy cleaning methods using mechanical tools and manned entry to the pipe. The remaining pipes showed some minor defects, such as cracks or fractures, but otherwise showed to be in good condition. In addition, VPS inspected an additional 100 foot long section of 84-inch pipe (000393SMH – 009022IN) that was not identified in the City's GIS. This pipe did not show any defects.

Approximate location of blockage and heavy debris. Inspection abandoned at this point.
